PHASE I INSPECTION REPORT NATIONAL DAM SAFETY PROGRAM

NAME OF DAM: LOWER WALLACE DAM
 LOCATION: AUGUSTA COUNTY, VIRGINIA
 INVENTORY NUMBER: VA. NO. 01527

Name of Dam: Lower Wallace Dam
State: Virginia
County: Augusta
USGS Quad Sheet: Greenville
Coordinates: Lat 38° 0.3' Long 79° 08.2'
Stream: Poor Creek
Date of Inspection: April 16, 1980

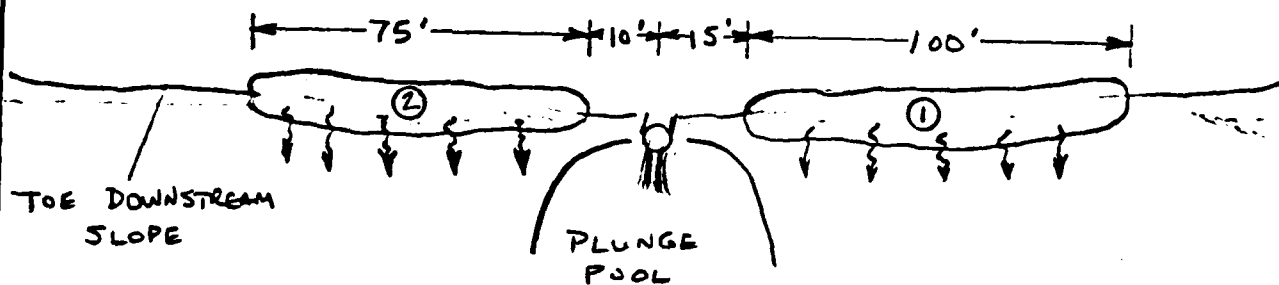
- ① SEEPAGE AREA 25 FT ± WIDE, WITH TOP OF AREA LOCATED 2 FT ± ABOVE THE TOE OF SLOPE. WET AREA 25 FT ± WIDE. NO FLOW OBSERVED, BUT DOES INCLUDE ABUNDANT IRON STAINING.
- ② SEEPAGE AREA 25 - 30 FT ± WIDE, WITH TOP OF AREA LOCATED 3 FT ± ABOVE TOP OF OUTLET PIPE. NO FLOW OBSERVED, BUT DOES INCLUDE ABUNDANT IRON STAINING.
